**Meeting of the DDA Board of Directors  
City Hall – Meeting Room A  
215 West Main Street  
November 20, 2018 - 8:00 a.m.**

CADY STREET PARKING STRUCTURE | FINAL REPORT

24183249.00 | August 6, 2018 | Engineering Condition Assessment

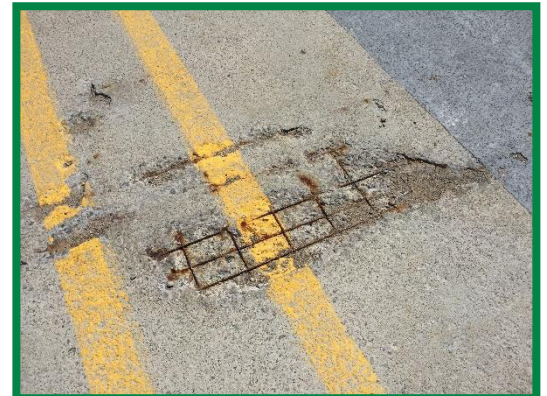
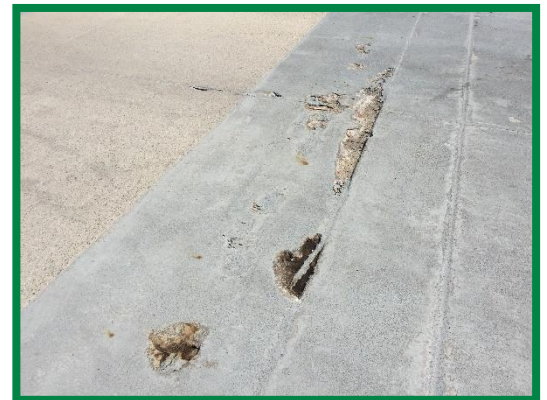
The chain drag survey of the floor slab revealed approximately 1,100 square feet of slab delaminations at the Upper Level, which is approximately 4.5% of the supported slab. The floor slab delaminations range in size from approximately 1 to 40 square feet. Many of the delaminations are caused by the corrosion of the welded wire fabric which appears to have very little concrete cover. Floor slab delaminations should be repaired to help maintain the structural integrity of the facility and eliminate safety hazards such as trip hazards.

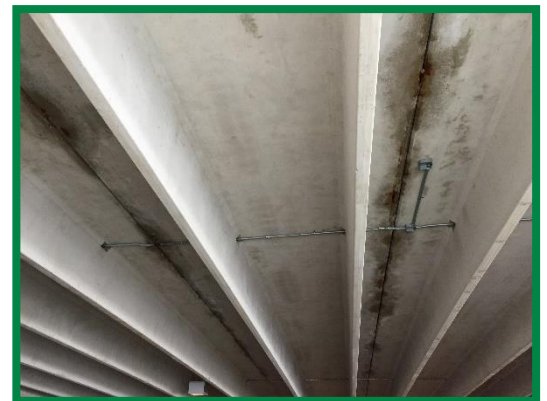
The double tees appear to be in good condition. We estimate a total of 80 square feet of tee flange delaminations, with most of them approximately 1 to 4 square feet in size. The delaminations are typically located along leaking joints that allow water and chlorides to corrode embedded reinforcement. These delaminations should be repaired to help maintain the structural integrity of the facility and eliminate safety issues such as falling concrete.

The tee stems appear to be in good condition. We estimate a total of 10 square feet of tee flange delaminations, with most of them approximately 1 to 2 square feet in size. These delaminations should be repaired to help maintain the structural integrity of the facility and eliminate safety issues such as falling concrete.

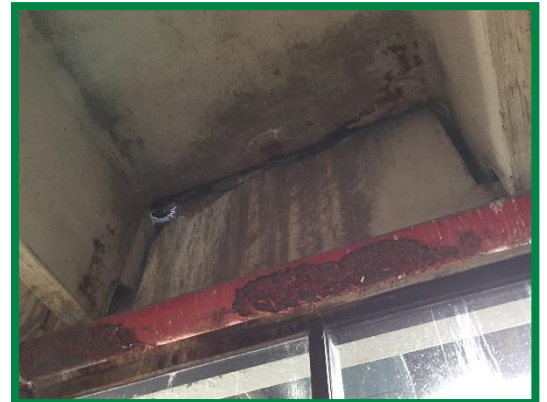
The beams appear to be in good condition. We estimated a total of 10 square feet of delaminations, with most of them approximately 1 to 5 square feet in size. The delaminations are typically located along leaking joints that allow water and chlorides to corrode embedded reinforcement. These delaminations should be repaired to help maintain the structural integrity of the facility and eliminate safety issues such as falling concrete.

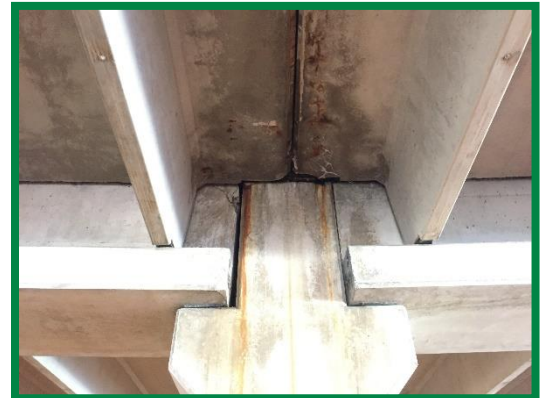
The columns appear to be in good condition with an estimated total of 10 square feet of delaminations. Most of the delaminations are small, approximately 1 to 2 square feet in size, and primarily located at the Lower Level adjacent leaking floor drains and risers. These delaminations should be repaired to help maintain the structural integrity of the facility and eliminate safety issues such as falling concrete.

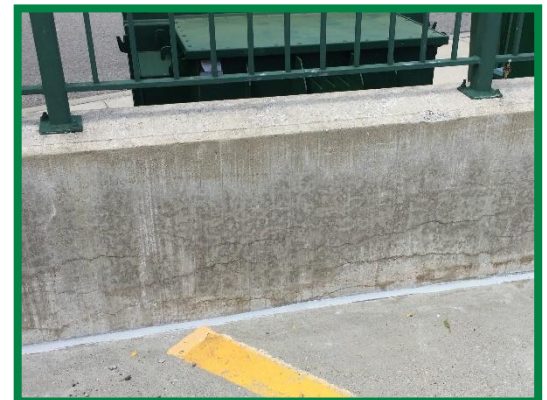
The precast concrete spandrels with brick veneer are located at the perimeter of the Upper Level. The spandrels appear to be in good condition with an estimated total of 10 square feet of delaminations. Most of the delaminations are small, approximately 1 to 2 square feet in size and primarily located near the columns. The delaminations at the interior face are typically caused by the corrosion of the reinforcement with shallow concrete cover. The deterioration at the exterior face appear to be caused by failed sealants, which allows moisture to penetrate behind the brick veneer. The moisture can then attack the concrete causing corrosion of the reinforcement, especially if there is shallow concrete cover on this face. Also, once moisture is behind the brick, freeze-thaw can cause damage to the concrete and the brick.

We observed areas of multiple hairline cracks at the interior face of the spandrels, which may be from alkali-silica reaction (ASR). To help protect these areas we would recommend installing a concrete sealer.

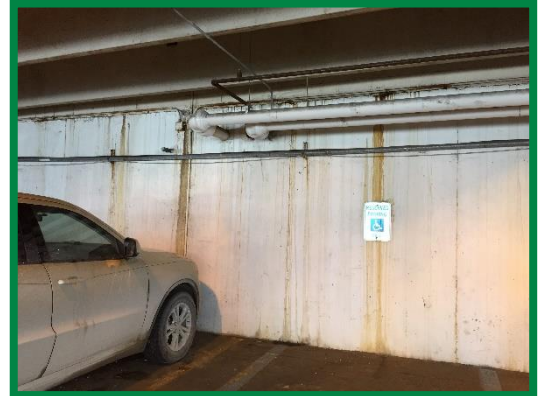
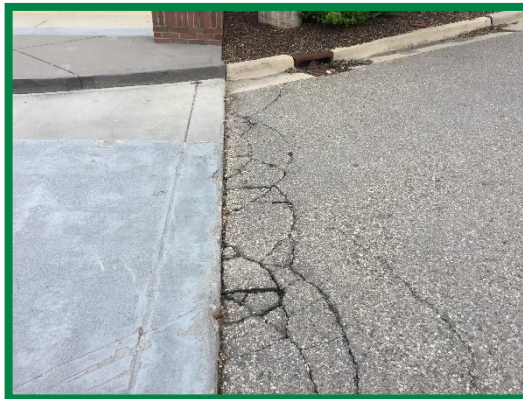
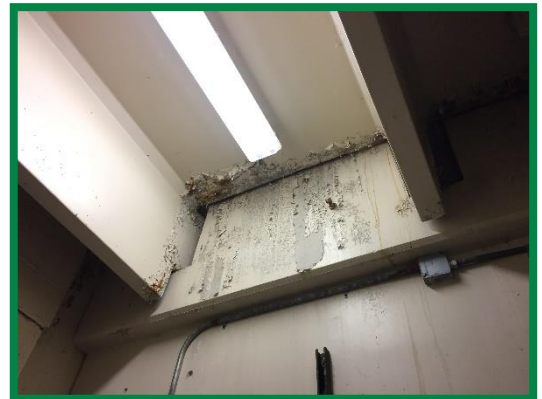
The cast-in-place concrete walls are located at the perimeter of the Lower Level. The walls appear to be in good condition with an estimated total of 10 square feet of delaminations. Most of the wall delaminations are small, approximately 1 to 4 square feet in size. The wall at the north end has a few leaking cracks that should be sealed to protect the wall from further delaminations. Also, there is leaking onto the north wall below the concrete-to-asphalt joint at the Upper Level entrance/exit and below the isolation joints at the northeast stair tower (elevator/electrical room). These joints above should be repaired to prevent the infiltration of water and chlorides.

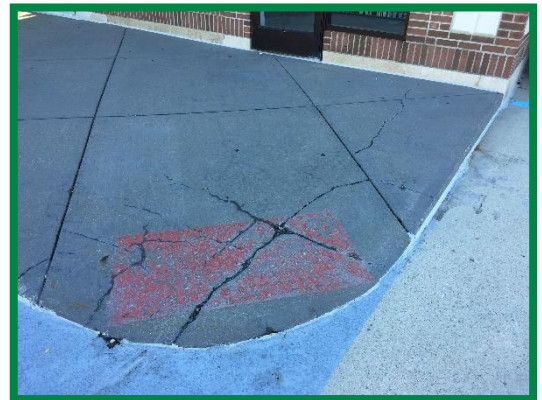
The concrete curbs are in fair condition with approximately 20 square feet of delaminations noted at the Upper Level. All of the curb delaminations were observed at the entrance/exit. The concrete curbs help direct water to the floor drains and provides a walking surface for pedestrians. These delaminations should be repaired to prevent potential trip hazards and to protect the embedded steel reinforcement.

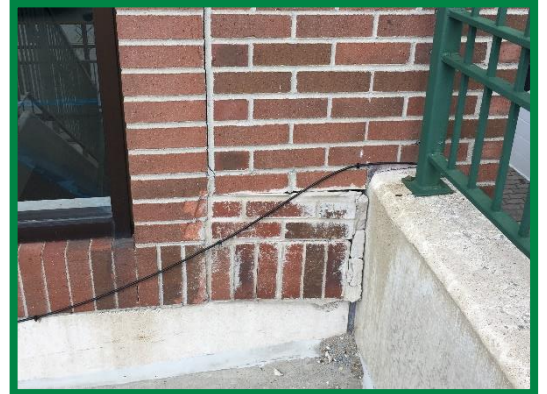
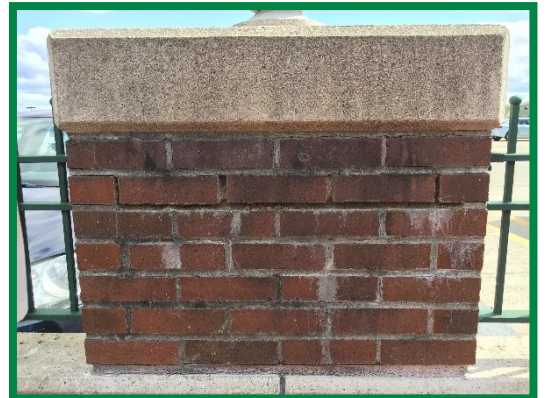
The exterior façade consists of precast concrete and brick masonry. The brick masonry appears to be in good condition, with some small areas deterioration observed. We observed spalls at the northeast stair tower and deteriorated mortar joints at the north exterior columns. All loose bricks and deteriorated mortar joints should be repaired to help prevent future deterioration.

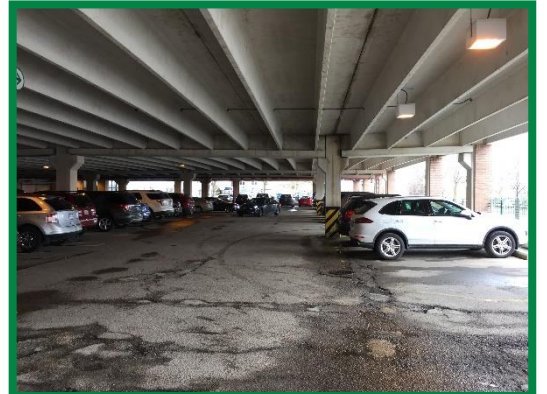
The Lower Level is at grade and the floor surface consists of asphalt. The asphalt throughout this level appears to be in fair condition with approximately 6,600 square feet of deterioration, which is approximately 24% of the floor surface. The paving seams are opening up which may lead to future deterioration of the asphalt. The asphalt should be repaired to reduce future deterioration and trip hazards.

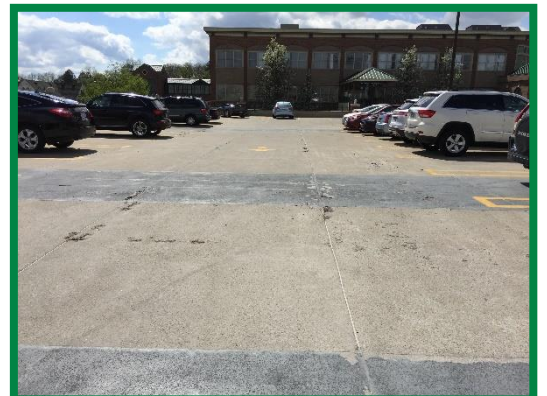
It is our understanding that a small quantity of the tee-to-tee joint sealants were repaired in 2005 and 2013. Failed tee-to-tee joint sealants and active leaking were observed throughout the Upper Level.

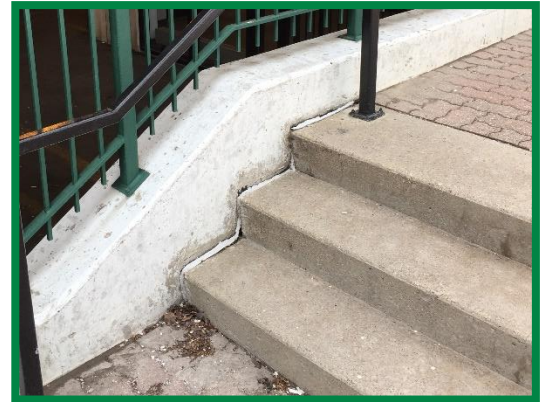
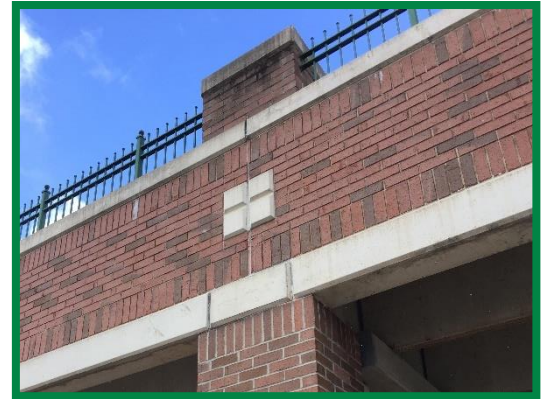
Cove joint sealants are typically installed at the slab-to-wall joints and slab-to-curb joints at the perimeter of the structure. The cove joint sealants appear to be in good condition throughout the Upper Level; they appear to have been recently replaced. Cracked and weathered sealants were observed at the exterior stairs and the pedestrian bridge.

Vertical and horizontal wall sealants at the interior and exterior of the structure are in poor condition. Cracked and weathered sealants were observed throughout the structure. Most of the wall sealants are located at the columns.

The typical service life for joint sealants is 7 to 10 years, especially at the roof level. Sealants should be repaired to prevent the infiltration of moisture and chlorides into the structural elements below and to prevent leaking onto vehicles and pedestrians at the Lower Level.

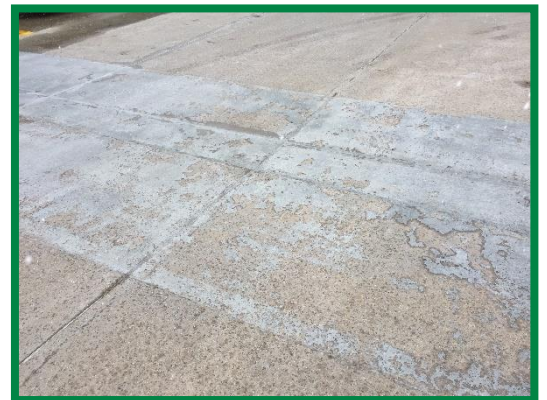
Deck coating has been installed at the Upper Level slab directly above the inverted tee beams along column lines B, C, and D, and at the entrance/exit. It is our understanding that the deck coating was replaced in the 2005 repair project. The deck coating appears to be in poor condition with many worn areas, especially in the drive lanes. All of the deck coating should be recoated to help protect the underlying structural concrete elements.

It is our understanding that a 40% silane sealer was applied to the Upper Level slab surfaces during the 2005 repair project. The effective service life of a 40% silane sealer is typically 4 to 5 years.

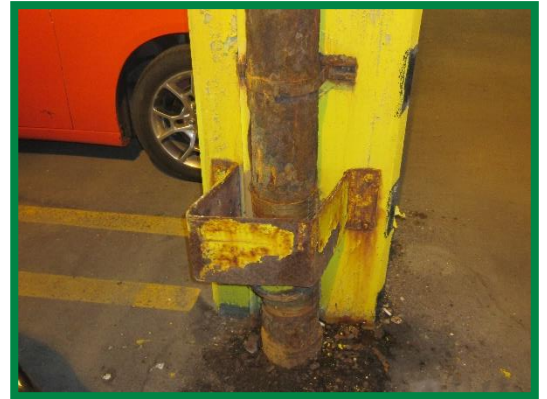
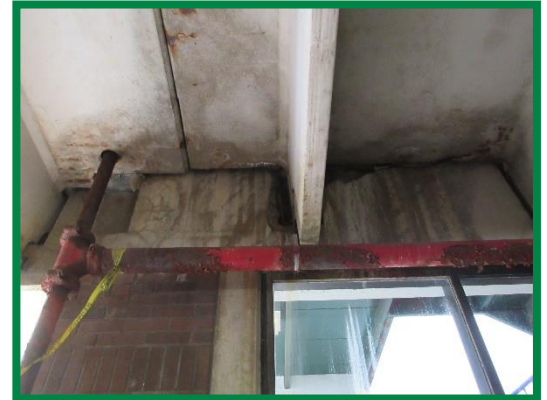
Cast iron storm drainage piping (vertical risers) are at four locations in the structure, along column lines B and D. Corroded and damaged cast iron piping were noted at three of the four locations, caused by leaking joints above. The damaged piping should be replaced to maintain proper water removal from the structure. Piping could be replaced with PVC to eliminate corrosion damage, if allowed by the local codes.

The steel pipe guards protecting the risers were all observed to be corroded. As a minimum, these should be cleaned and repainted or better yet, replaced with new galvanized pipe guards.

The standpipe system has been painted, which helps protect the steel from corrosion. Most of this paint is deteriorating, causing corrosion. The standpipe system should be cleaned and repainted. A section of severely corroded standpipe near the northwest stair tower should be replaced to maintain the proper function of the system. The system should also be tested, if it has not been recently, to make sure it is working properly.

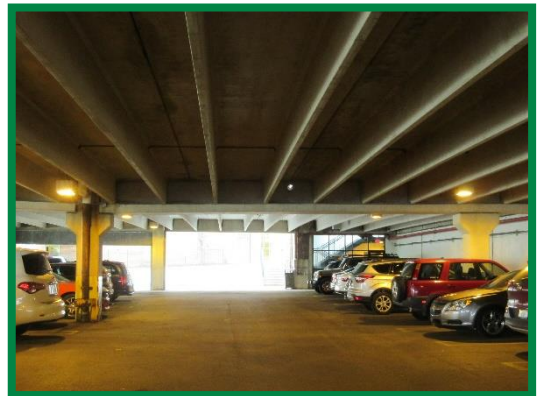
HPS light fixtures at the Lower Level are located near the edges of the drive lane at a spacing of approximately 30 feet. The fixtures are surface mounted to the underside of the slab and are serviced by exposed electrical conduit. The lighting system appears to be in good working order. WGI can conduct a lighting survey to review existing lighting levels and provide recommendations to improve (increase) lighting levels while using more energy efficient fixtures. LED lighting technology is available that could provide energy savings as well as a longer bulb life.

Electrical junction boxes and conduits were noted to be corroded due to leaking joints above. The conduits and junction boxes should be repaired to prevent future deterioration and possible electrocution.

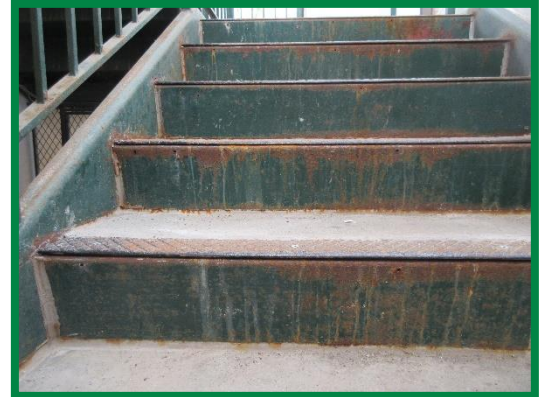
The stair towers consist of metal pans with concrete infill. The northeast stair/elevator tower appears to be in good condition, while the northwest stair tower appears to see more foot traffic and is in relatively fair condition.

- Stairs and handrails were observed to be corroded; steel surfaces should be cleaned and repainted (touch-up only at underside).
- Existing sealant appear to be in good condition.
- Upper Level landing has a mat adhered to the floor. We recommend removing the mat flooring and replacing with cove joint sealants and deck coating.
- A full system deck coating should be added to the stair treads and landings to help protect the underlying structure.
- Exterior door fails to close at the Upper Level and should be repaired.
- Interior paint at walls and ceiling appears to be in good condition.

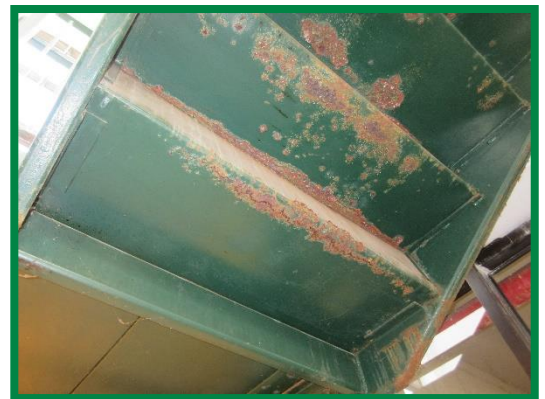
- Stairs and handrails were observed to be corroded; steel surfaces should be cleaned and repainted.
- Isolated areas of severe corrosion were observed, including five tread pans and one landing panel that were damaged and should be replaced.
- Existing sealant appear to be in good condition.
- Deck coating has been applied to the floor at the top two landings. The deck coating appears to be in good condition.
- A full system deck coating should be added to the stair treads and untreated landing to help protect the underlying structure.
- Interior paint at walls and ceiling appears to be in good condition.

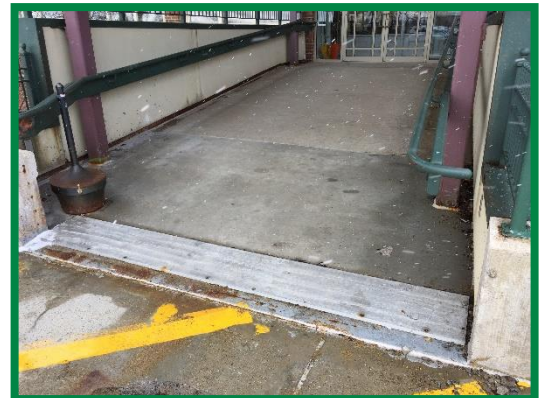
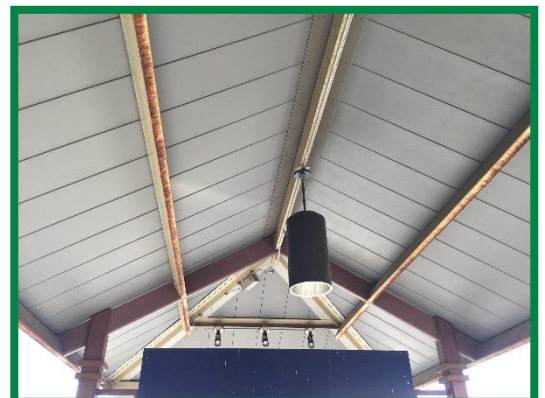
The pedestrian bridge appears to be in relatively good condition. The bridge is not original to the structure and was constructed of steel framing members, standing seam metal roof, concrete supported slab, and cement board ceiling at the underside of bridge.

- Cracked and weathered sealants should be replaced.
- Existing deck coating at the bridge floor is worn and should be recoated.
- A full system deck coating should be added to the untreated floor area to help protect the underlying structure.
- Tube Steel (columns, beams and handrails) was observed to be corroded; steel surfaces should be cleaned and repainted.

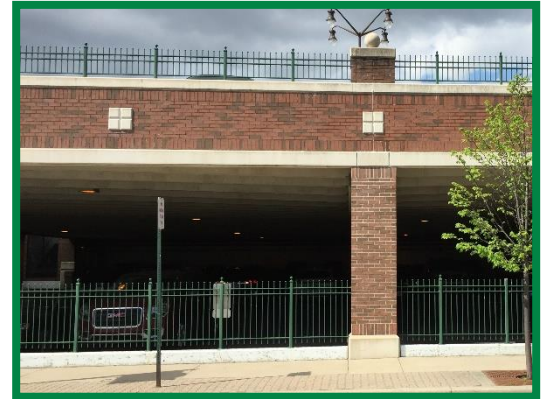
The steel railings around the perimeter of both levels were observed to be corroded in areas with peeling paint throughout. As a minimum, these corroded areas should be cleaned and repainted.

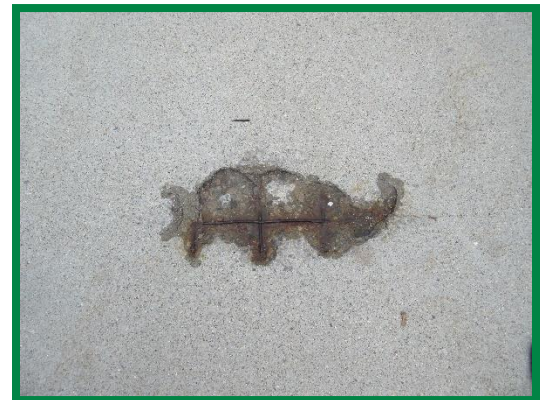
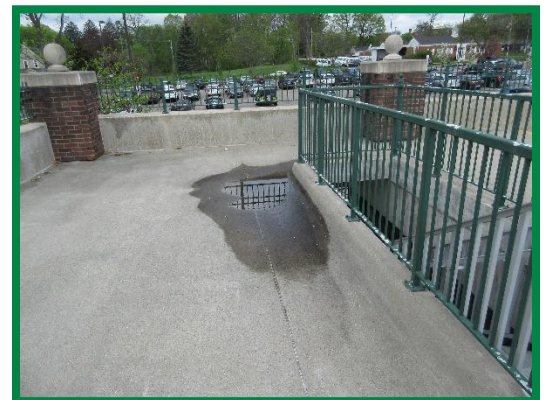
Water ponding was observed at the Upper Level Adjacent to the southwest stairs. This ponding could be relieved by minor re-profiling or installing a supplementary floor drain.

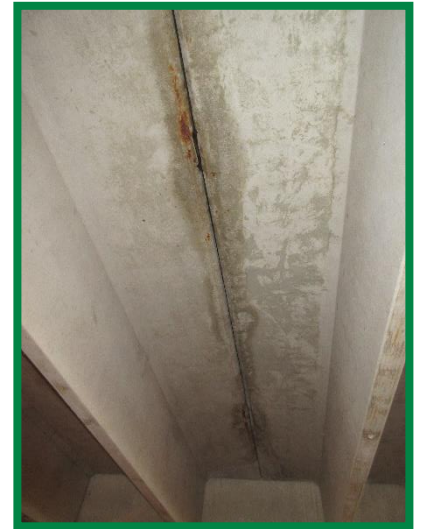
The tee stems appear to be in good condition. No delaminations were noted at the stems.

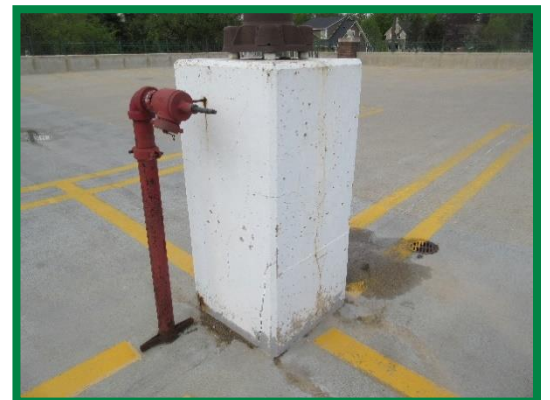
The interior columns at the Upper Level, a total of three, are used to support the light posts. These columns have multiple hairline cracks, which may be from alkali-silica reaction (ASR). To help protect these columns we would recommend installing an elastomeric coating.

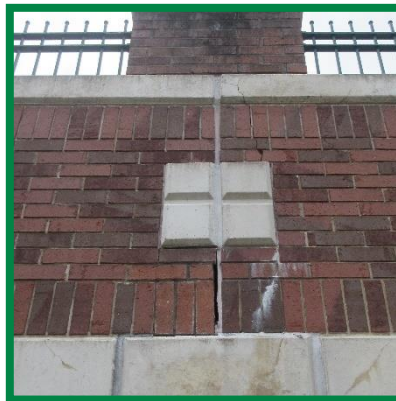
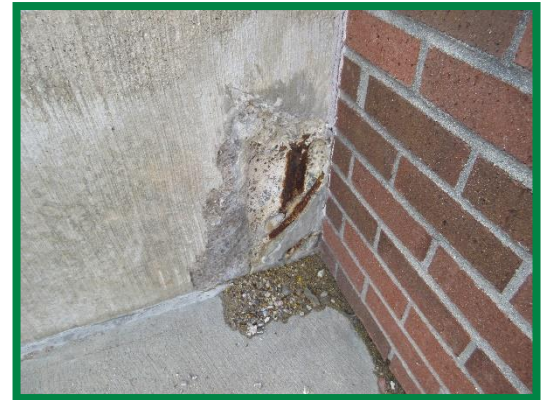
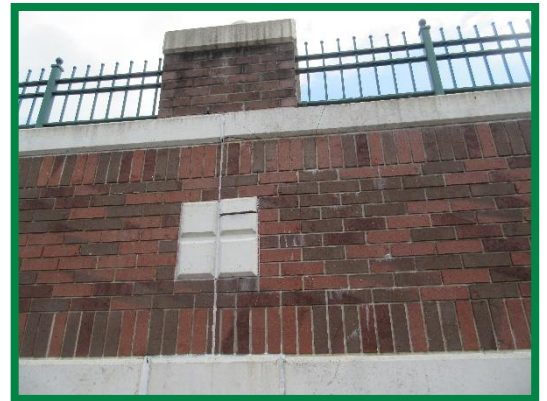
The precast concrete spandrels with brick veneer are located at the perimeter of the Upper Level. The spandrels appear to be in good condition with an estimated total of 30 square feet of delaminations. Most of the delaminations are small, approximately 1 to 2 square feet in size and primarily located near the columns. The delaminations at the interior face are typically caused by the corrosion of the reinforcement with shallow concrete cover. The deterioration at the exterior face appear to be caused by failed sealants, which allows moisture to penetrate behind the brick veneer. The moisture can then attack the concrete causing corrosion of the reinforcement, especially if there is shallow concrete cover on this face. Also, once moisture is behind the brick, freeze-thaw can cause damage to the concrete and the brick.

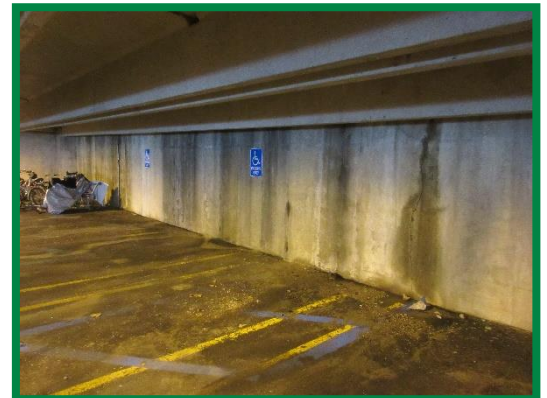
The cast-in-place concrete walls are located at the perimeter of the Lower Level. The walls appear to be in good condition with an estimated total of 20 square feet of delaminations. Most of the wall delaminations are small, approximately 4 to 6 square feet in size. The wall at the north end has multiple leaking cracks, which has helped cause the delaminations. Also, the expansion joint above at the entrance has failed causing leaking on to the wall. The cracks and expansion joint needs be sealed to protect this wall.

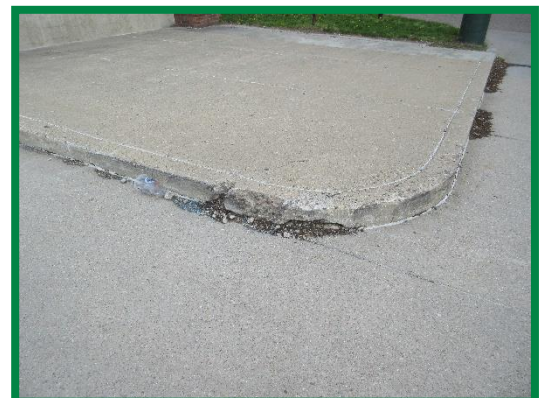
The concrete curbs are in good condition with approximately 20 square feet of delaminations noted at the Upper Level. At some locations the deterioration is undermining the curb. All of the curb delaminations were observed at the entrance/exit. The concrete curbs help direct water to the floor drains and provides a walking surface for pedestrians. These delaminations should be repaired to prevent potential trip hazards and to protect the embedded steel reinforcement.

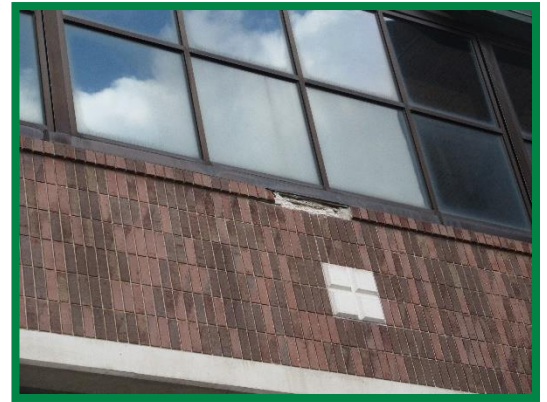
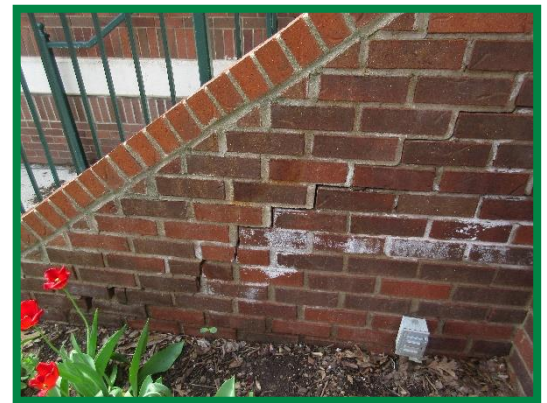
The brick stair retaining wall at the northwest corner was rebuilt in 2005. A crack in the north face of the wall has developed. The cove joint sealant between the brick and steps has failed, causing moisture to enter the backside of the wall. Thermal movement of the concrete steps and freeze-thaw has most likely caused this crack.

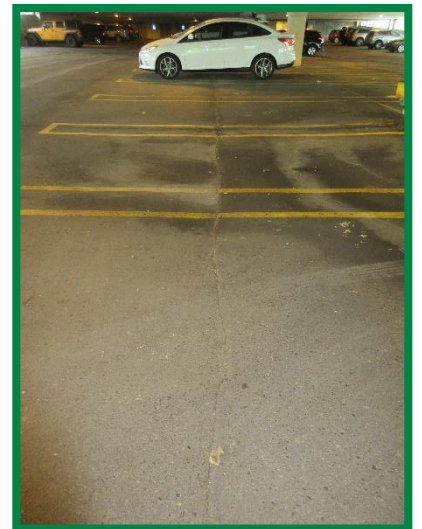
The Lower Level is at grade and the floor surface consists of asphalt. The asphalt throughout this level is in good condition with approximately 240 square feet of deterioration, which is approximately 0.9% of the floor surface. The paving seams are opening up which may lead to future deterioration of the asphalt. The asphalt should be repaired to reduce future deterioration and trip hazards.

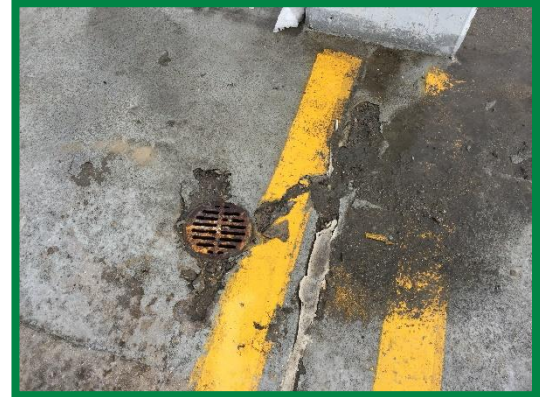
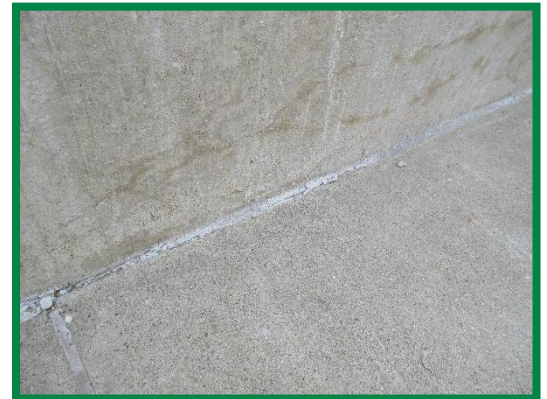
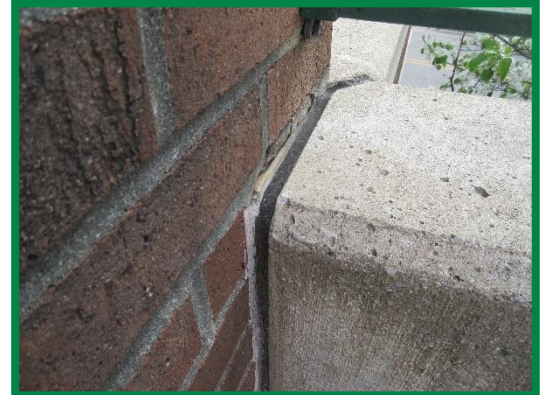
Most of these sealants appear to be very old and are at the end of their useful life. The typical service life for joint sealants is 7 to 10 years, especially at the roof level. Sealants should be repaired to prevent the infiltration of moisture and chlorides into the structural elements below and to prevent leaking onto vehicles and pedestrians at the Lower Level.

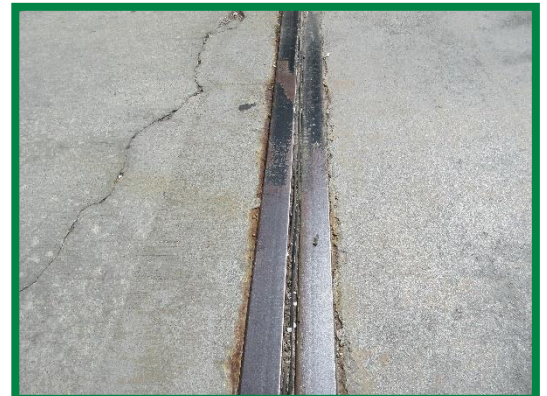
There is an expansion joint running east-west at the entrance/exit to the Upper Level. The purpose this joint is to provide isolation from the structural slab and the foundation which allows movement to occur without causing damage to the structure. The joint consists of steel angles with a compression seal (Jeene Joint). The gland was replaced in 2013. The gland has failed causing leaking below and corrosion damage to the foundation wall. This gland should be replaced to prevent water from damaging the structural elements.

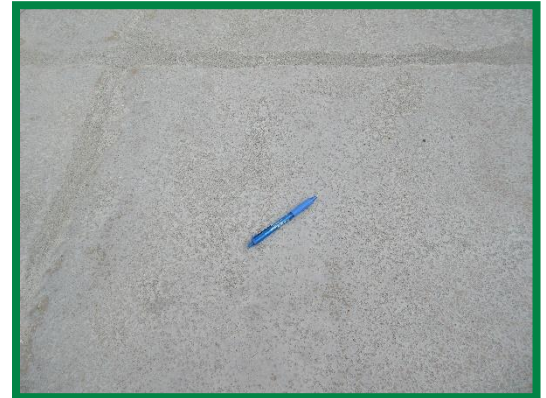
It is our understanding that a 40% silane sealer was applied to the Upper Level slab surfaces during the 2005 repair project. The effective service life of a 40% silane sealer is typically 4 to 5 years.

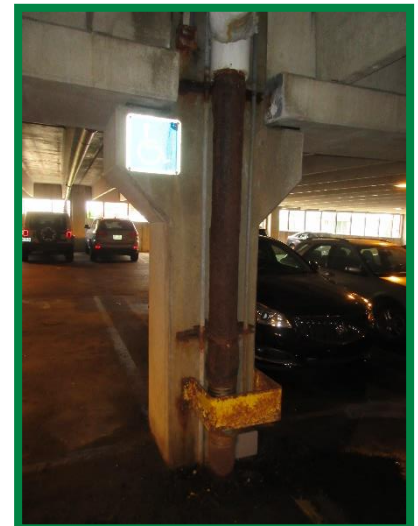
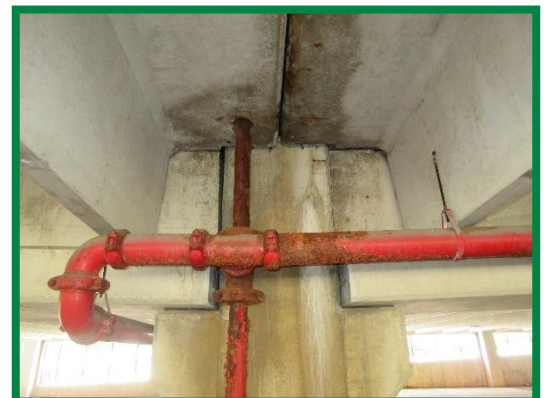
The standpipe system has been painted, which helps protect the steel from corrosion. Most of this paint is deteriorating, causing corrosion. The standpipe system should be cleaned and repainted. The system should also be tested, if it has not been recently, to make sure it is working properly.

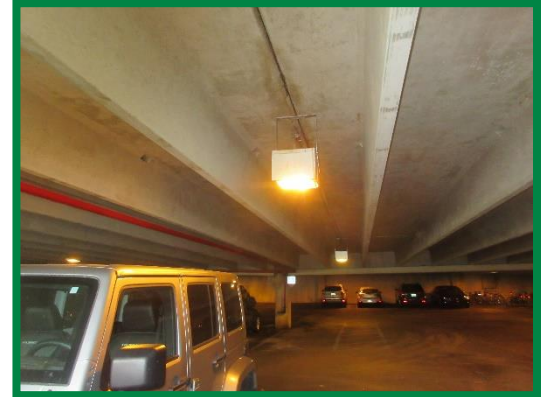
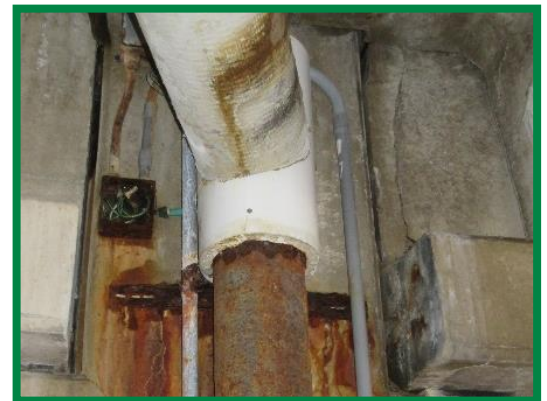
Electrical junction boxes and conduits were noted to be corroded due to leaking joints above. Some of the boxes were missing covers exposing the wires. The conduits and junction boxes should be repaired to prevent future deterioration and possible electrocution.

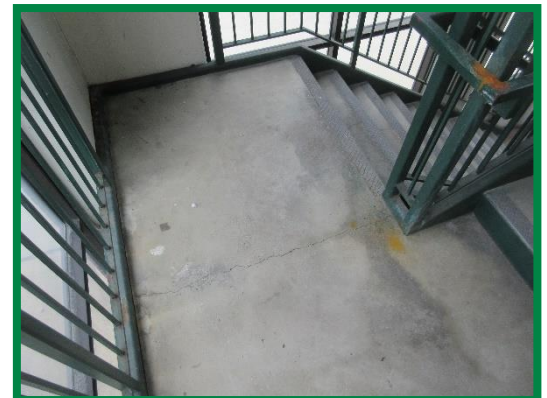
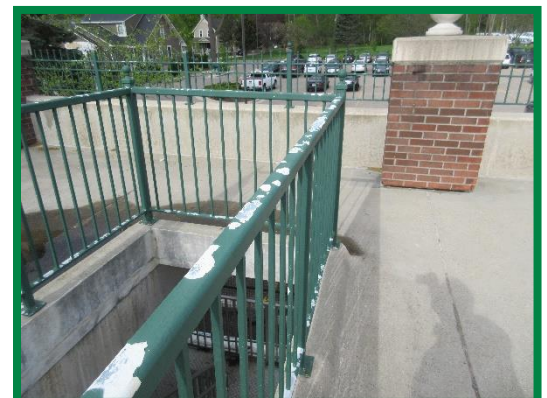
- Paint peeling from the rail around the stairs at the Upper Level.
- One riser missing from the stairs.
- Bottom of door frame corroded at the Lower Level.

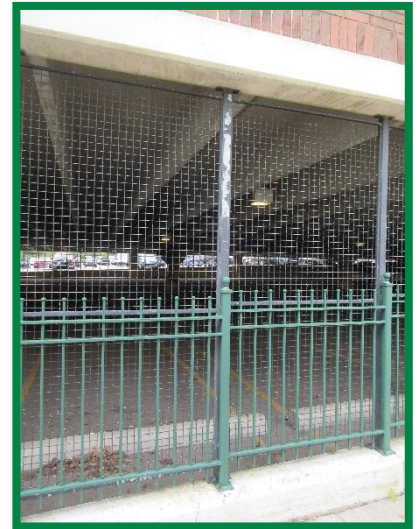
The steel railings around the perimeter of both levels and the security fencing around the perimeter of the lower level were observed to be corroded in areas with peeling paint throughout. As a minimum, these corroded areas should be cleaned and repainted.
